INACTIVE AND ABANDONED MINE LANDS— Gladstone and Electric Point Mines, Northport Mining District, Stevens County, Washington

WASHINGTON
DIVISION OF GEOLOGY
AND EARTH RESOURCES
Open File Report 2004-19
September 2004

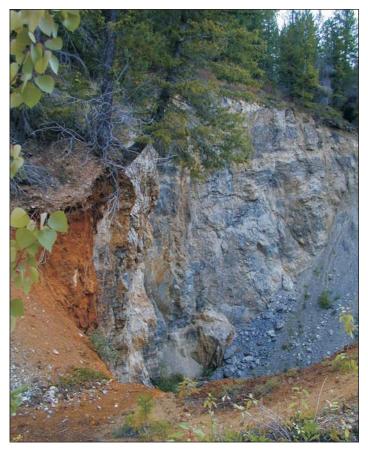
Mineralization occurred in vertical, highly oxidized chimneys at both mines. The chimneys are circular or oval in plan view, ranging from 30 to 150 feet in maximum diameter and from 150 to 800 feet in depth. At Electric Point, a glory hole sunk on one of the chimneys is roughly 150 feet in diameter by 300 feet deep. The walls are vertical and the perimeter is unfenced. This feature is one of the most hazardous surface excavations thus far documented in the IAML survey (Fig. 3).

Figure 3. Glory hole at Electric Point mine. View to the west.

The most prominent feature at Electric Point is the glory hole 150 feet in diameter and 300 feet deep. The sides of dolomitic limestone are mostly vertical and the peripheral rim is unpro-

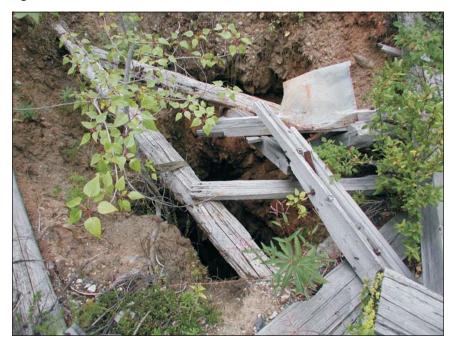
Figure 4. Moonlight shaft collar, Gladstone mine.

(G) open pit or caved shaft (125)		no	50	30	15			48.88538	117.5432
(G) open pit or caved shaft (126)		no	30	30	8			48.88549	117.5435
(G) shaft (Moonlight?)(127)	open	no	6	6	300*		Fig. 4	48.88592	117.5439

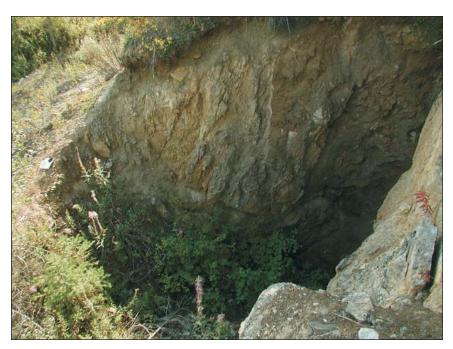
Figure 5. Anderson shaft collar, Gladstone mine.

(G) shaft (Anderson?)(129)	open	no	6	6	30 highwall		Fig. 5	48.88621	117.5442
(G) open pit (130)		no	50	50	30		DSCN2421**	48.88683	117.5443
(G) open pit or caved shaft (Johnson?)(134)			40	40	20		DSCN2422**	48.88667	117.5441

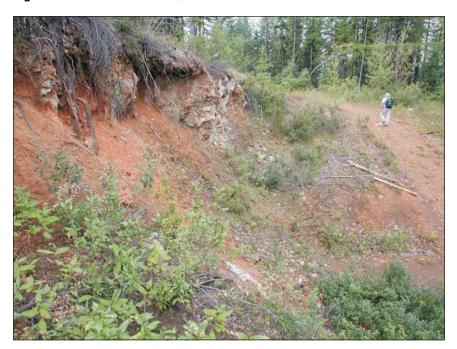
Figure 6. Typical exposure of circa-1946 dozer trenching, Gladstone mine.

(G) dozer trench circa 1946-1950 (72)	typical	no	200	25	10		Fig. 6	48.88468	117.5466
(G) found corner, patent claims: NE Setting Sun, SE Moonlight (71)								48.88552	117.5445
(EP) burned building (142)		no	40	30	40		none	48.88411	117.5419
(EP) open cut with adit at west end (143)		no	130	50	40 vert.			48.88353	117.5417
(EP) open cut with adit at east end; two 5000 gallon tanks, empty (144)	back has fallen out of adit; support stulls are 3 feet from overhead	no	40	70	20	S65W	Fig. 8	48.88324	117.5417
(EP) open cut (145)		no	140	70	35 vert.		DSCN2442**	48.88271	117.5418
(EP) concrete foundation	on east rim of gloryhole	no					DSCN2443**	48.88255	117.542
(EP) glory hole (147)	open	no	150	150	300 vert.		Fig. 3	48.8824	117.5424
(EP) caved portal, site of "300 level" access tunnel, elevation 4160 (148)	caved	no	600*	5	7	N32E		48.88173	117.5428
(EP) waste rock dump (151)		no	50	60	30			48.88271	117.5411

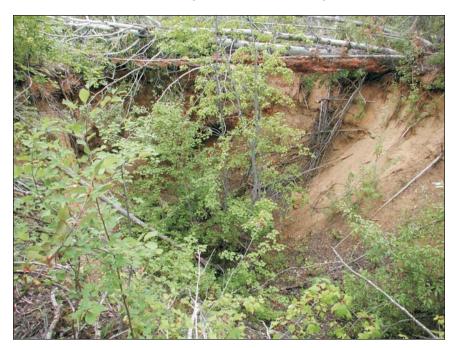
Figure 7. General location of Setting Sun shaft, Gladstone mine.

(G) conical tailings (137)			40	40	30		DSCN2429**	48.88745	117.5438
(G) shaft (Setting Sun)	caved alluvium around former opening	no	40	40	30		Fig. 7	48.88542	117.5459

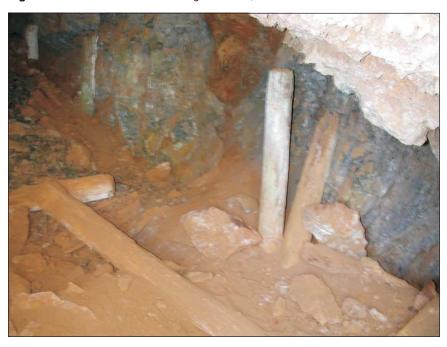
Figure 8. Adit on Electric Point mine. Note distance between rock overhang and top of drift timber.

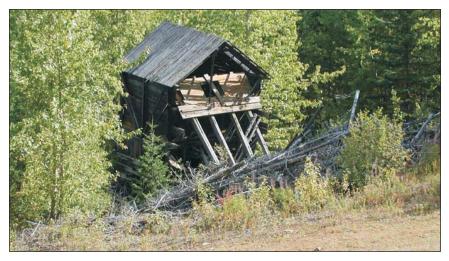
The only recognizable structure at Gladstone was what may have been a combination ore-sorting house, storage bunker, and loading point (Fig. 9). This structure can be seen in the historic photo in Figure 10.

Figure 9. Loading bunker/sorting house at Gladstone mine.

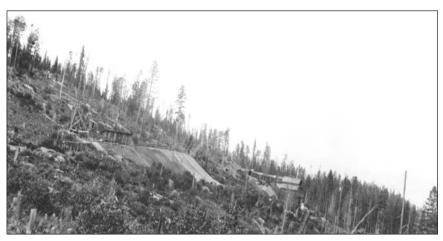
Figure 10. Overview of Gladstone mine area, 1924. Photo by Olaf P. Jenkins. Structure in Figure 9 at right. View to the north.

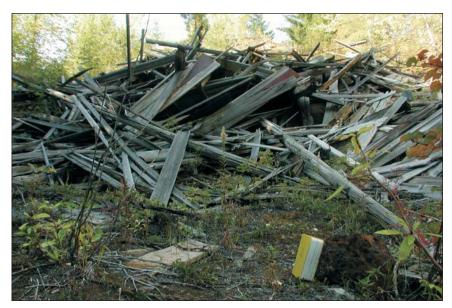
Figure 11. Mill ruins at Electric Point mine. Notebook for scale.

(EP) mill ruins (153)	collapsed	no	40	40			Fig. 11	48.88252	117.5405

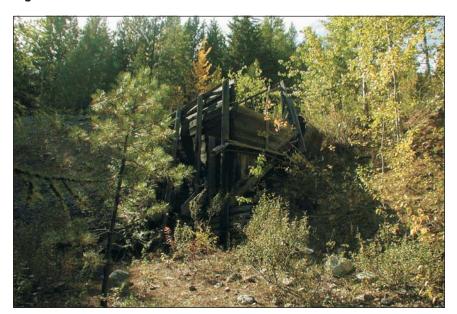
Figure 12. Loading bunker/sorting house at Electric Point mine. View to the south.
